**PRODUCTIVE LAND USE SYSTEMS**  
**Haiti**

**Technical Assessment of the Irrigation Systems of Marigot  
and Jacmel and Preliminary Observations  
on the Marigot Watershed**

**Kyung H Yoo and Dennis A Shannon**

**SECID/Auburn PLUS Report No 47  
USAID/Haiti Agriculture and Economic Growth Office**

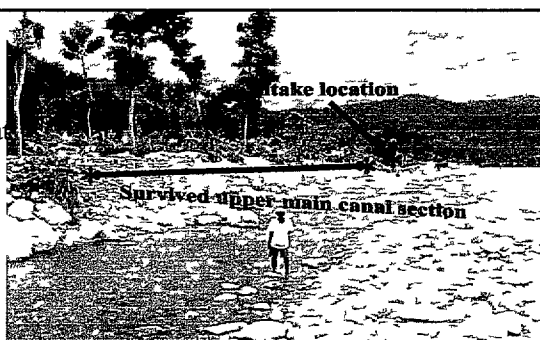
**Photo 10** Damaged upper section of main canal at the Belle Roche site. The rock-walled section of the main canal survived the flooding but the left end of the section was completely cut off.
